APOLLO 16

ANOMALY REPORT NO. 2

WATER/GLYCOL TEMPERATURE CONTROL  
CIRCUIT FAILED IN THE AUTOMATIC MODE

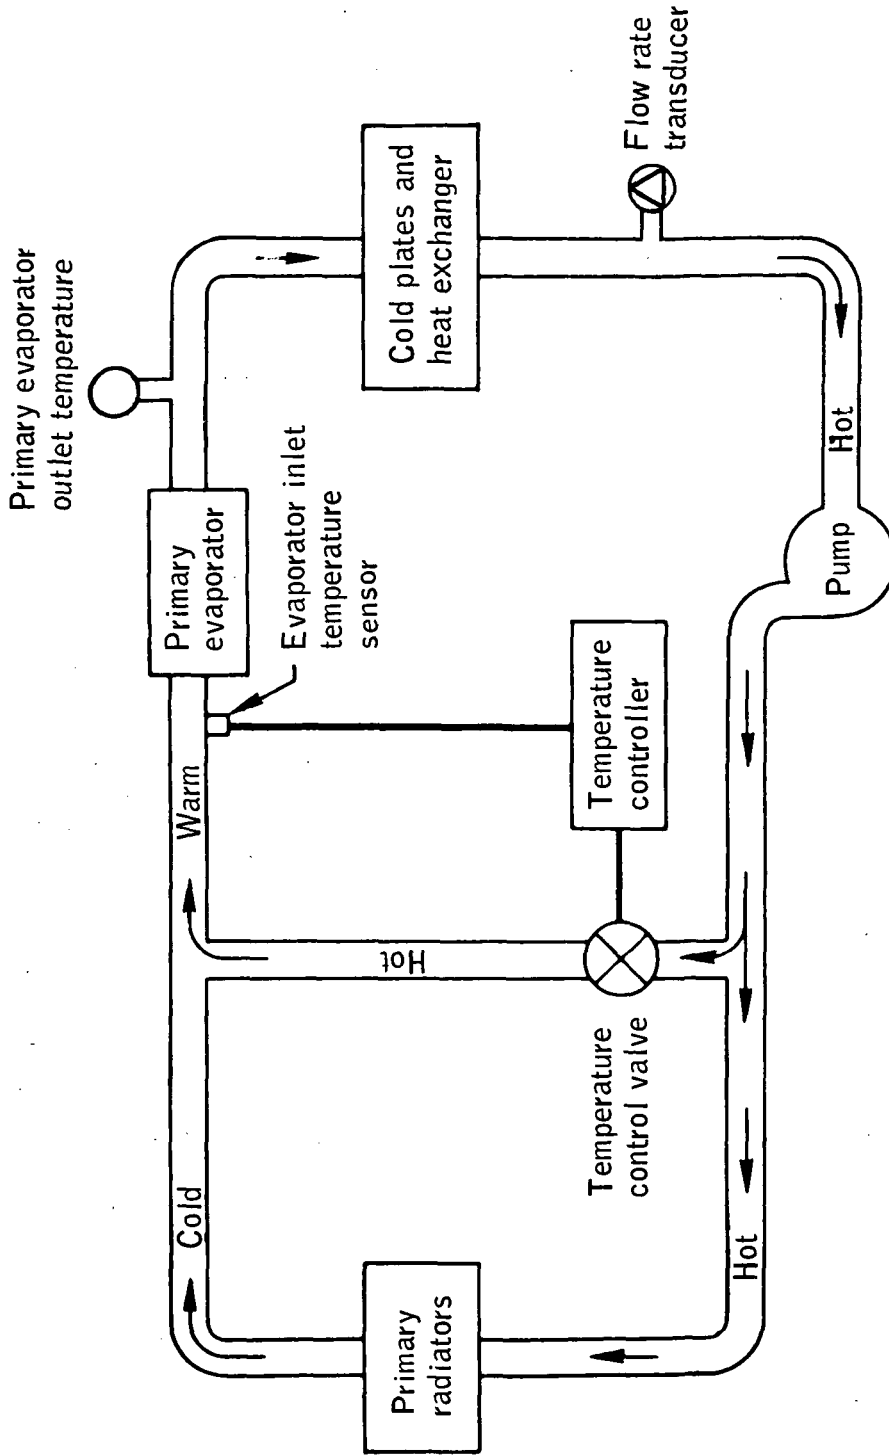
Figure 1.- Primary water/glycol coolant loop.

The water/glycol temperature control circuit (fig. 1) malfunctioned in the automatic mode about 3 hours into the mission. The malfunction allowed an excessive amount of hot water/glycol to bypass the radiator, causing the temperature of the mixed water/glycol to exceed the upper control limit of 48° F. After remaining in the maximum bypass flow position for 5 minutes, the temperature control valve cycled regularly between the maximum bypass flow and minimum bypass flow condition for about 14 minutes before again stopping at maximum bypass flow. The control was changed to the manual position and back to the automatic position to restart the valve operation. This was not successful in restoring normal operation and the valve was placed in the manual position at the desired temperature valve setting. Variations in the evaporator outlet temperature and total system flow rate for the 14-minute erratic period are shown in figure 2. Control valve operation is evident from the variation in system flow rate.

The spacecraft cabin atmosphere and electrical equipment temperatures are maintained at desired levels by the water/glycol coolant loop. Heat is rejected by the coolant as it circulates through the space radiators and the water evaporator (fig. 1). An automatic valve controls the coolant bypass flow around the radiators to maintain the desired evaporator inlet temperature of  $45 \pm 3^{\circ}$  F.

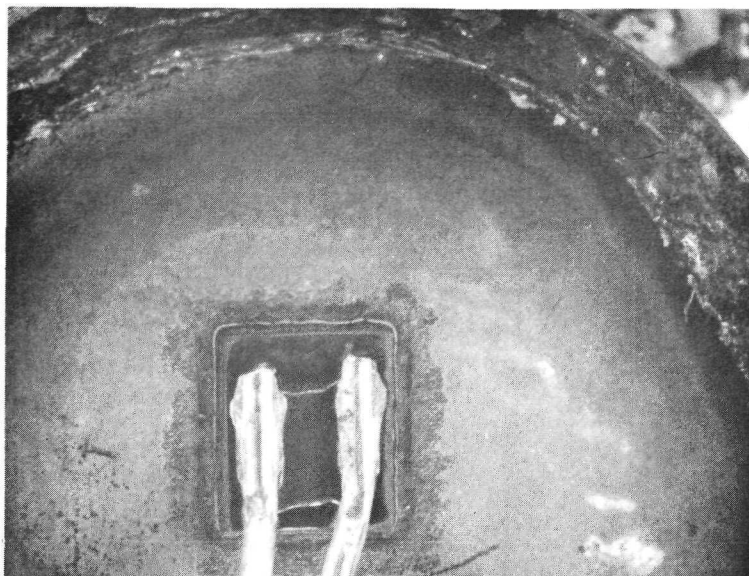
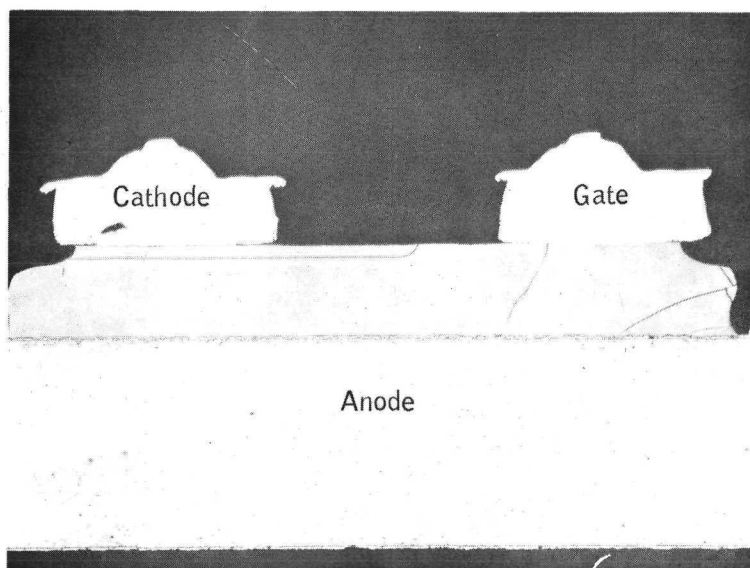
Figure 4.- Defective silicon-controlled rectifier.

Both output silicon-controlled rectifiers were removed from the controller for analyses. One rectifier semiconductor chip was found cracked (fig. 4). The other rectifier was pierced with a gas sampler and air was found inside the case instead of the required inert atmosphere. Oxygen inside the case can cause rectifier degradation. Both rectifiers were leak-checked and leak rates were about 100 times the specification value of  $10^{-10}$  scc/sec. This value is high enough to allow atmosphere exchange during seven years since the device was manufactured.

A controller on the Apollo 17 command module also displayed a continuous on condition in one channel. The rectifier in that channel also had a cracked semiconductor chip. The cracks in both the Apollo 16 and 17 rectifiers extended from under the gate lead, through both junctions, to the anode as shown in figure 4.

The cracks in the semiconductors could have been caused in manufacturing, during thermal-compression bonding of the large aluminum gate lead to the chip, or by handling when the controller was being assembled. Many failures occurred because of handling after the units used in the water/glycol temperature controllers had been manufactured. As a result, the manufacturer changed the design of the rectifier case because flexing of the base by forming the leads was cracking the chips.

Experience has shown that surface contaminants in a crack extending from the anode to the gate can provide a leakage path between the rectifier anode and gate (ref. 1). Further, resistance of such a leakage path will decrease as the temperature and applied voltage increase, and will decrease with time when a constant voltage is applied.

The output silicon-controlled rectifier semiconductor chips were cracked. Surface contamination in the crack then allowed the device to self-gate on and remain on, resulting in a secondary failure of the feedback capacitor.

All remaining controllers have been tested for forward breakdown voltage at ambient and elevated temperatures. This test is the only practical test that can be performed and the test is not totally conclusive. If a controller fails in flight, manual valve control is satisfactory.
